STRAIGHT

LINES

WINTER 2018

Spicer
group

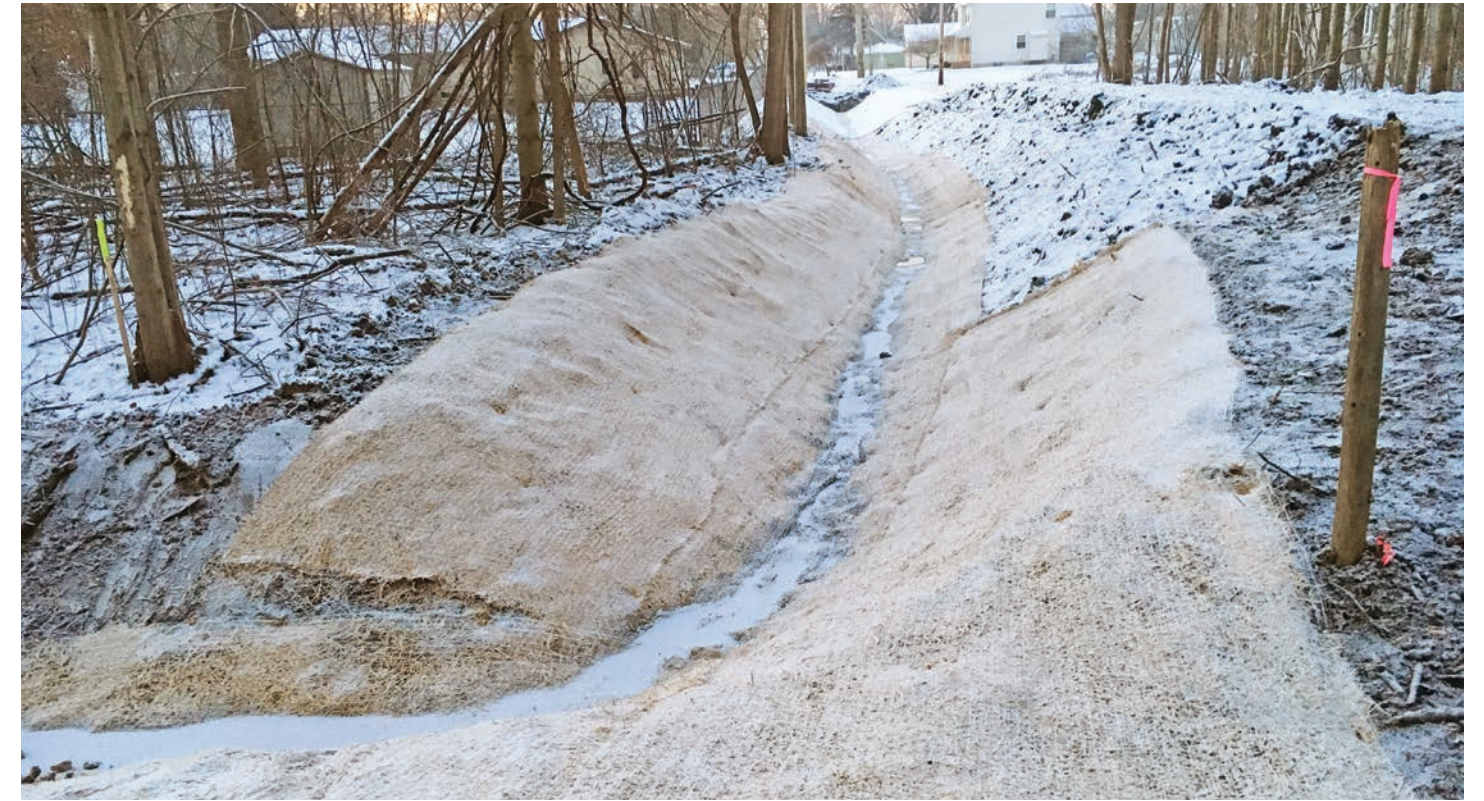
New open-drain portion of the project.

"We advised that the original clay tile should be abandoned in place and that the section of drain south of Willow Road be relocated, and the section of drain north of Willow Road be replaced," Mattson said. "But we had to figure out how to fix the problem as quickly as possible, yet make it practical so the

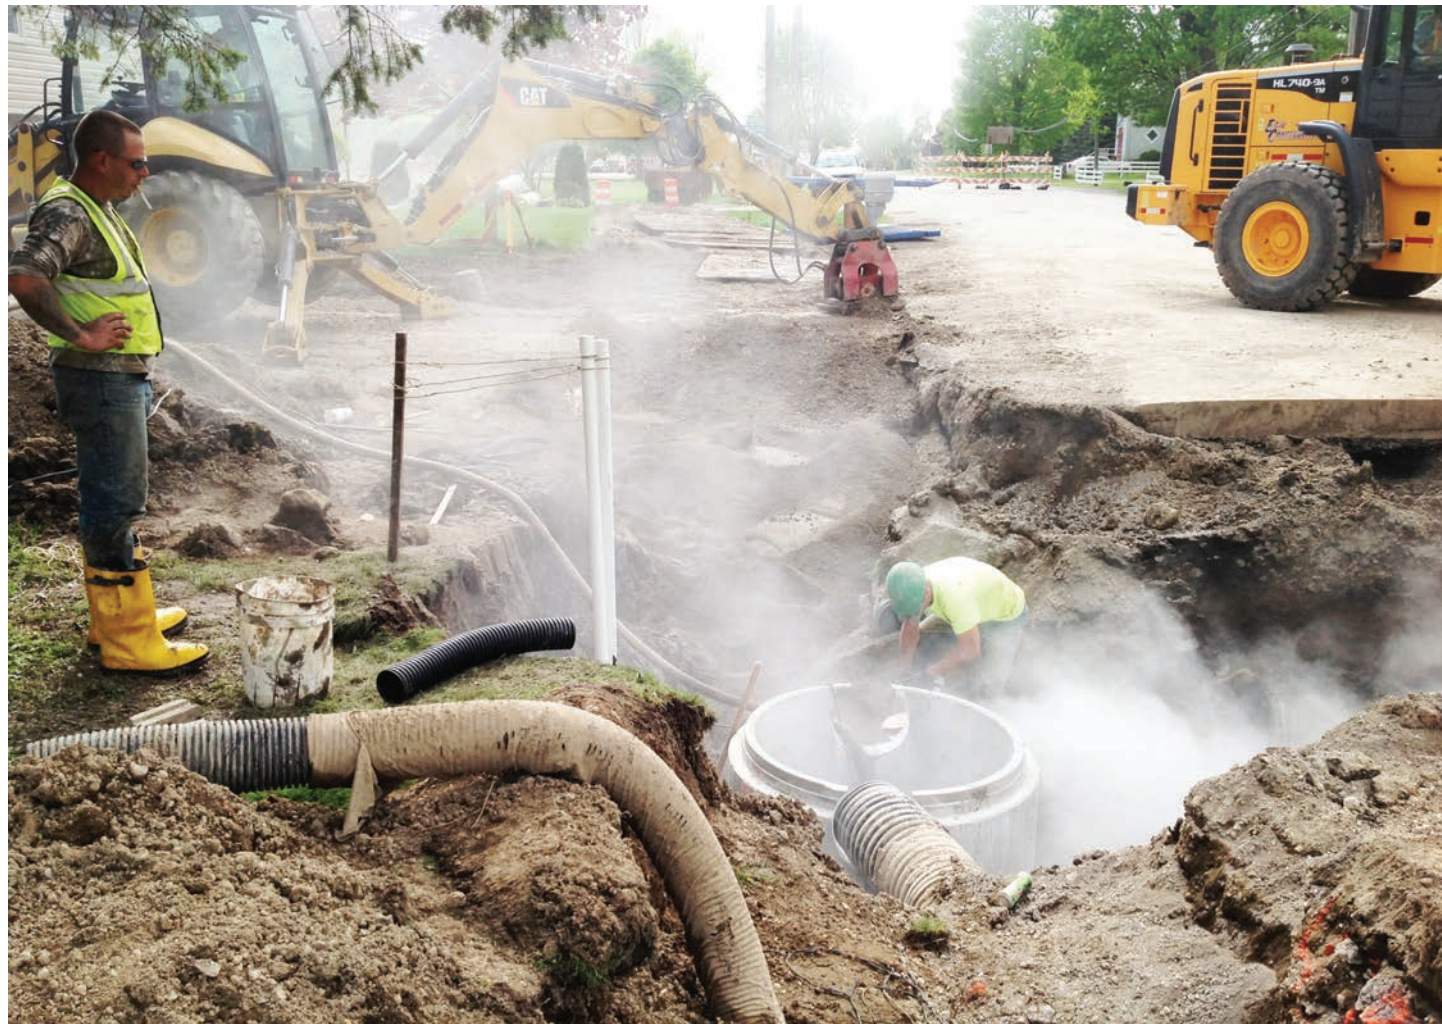
A new concrete storm sewer was installed along Denning Street and along the north edge of a neighboring sod farm to connect to an existing portion of the tile downstream that was replaced in the 1980's.

Improved open-channel portion of the drain.

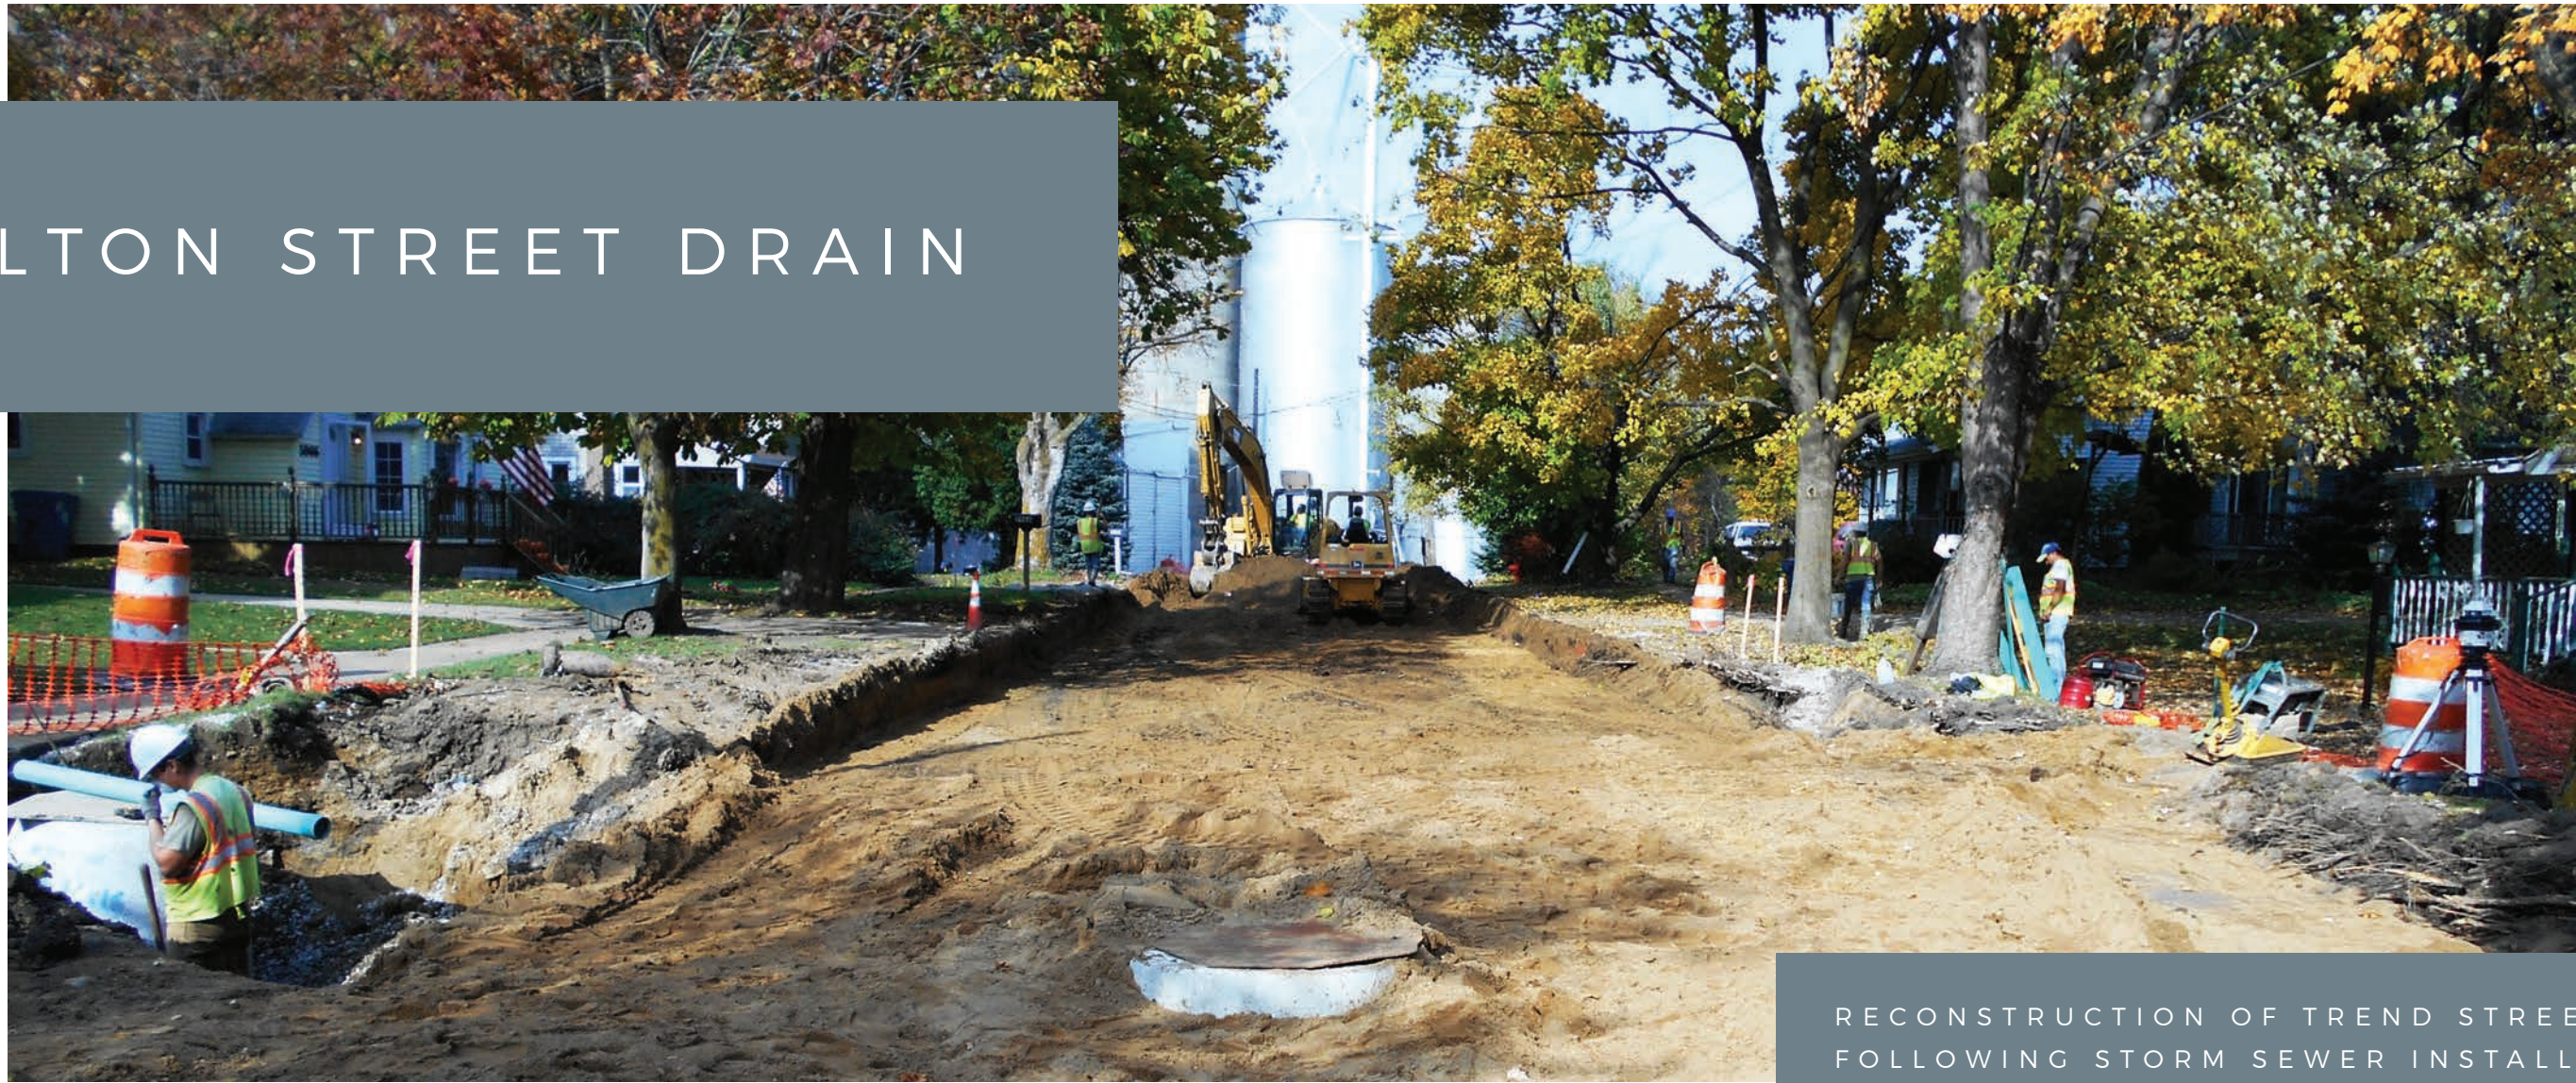
RECONSTRUCTION OF TREND STREET
FOLLOWING STORM SEWER INSTALLATION

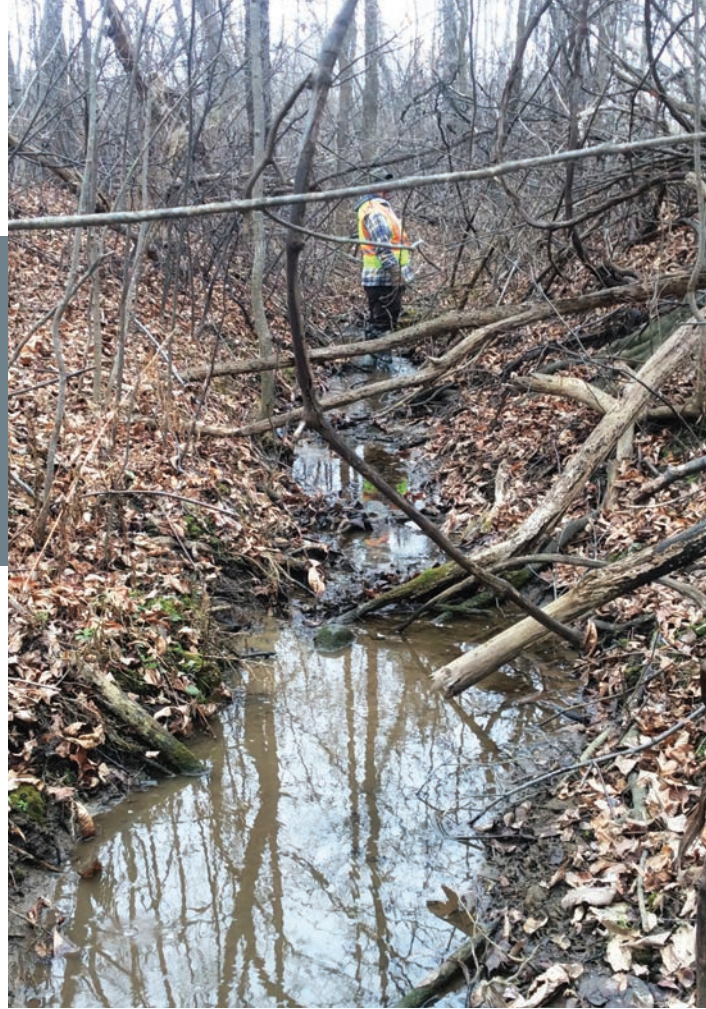
FIELD INSPECTION
OF THE ORIGINAL
DRAINAGE
ROUTE PRIOR TO
CONSTRUCTION.

According to Czerwinski, broken and collapsed sections of the old clay-tile drainage system combined with the natural topography of the area and an undersized outlet into a wetland area was the main cause of the flooding problems.

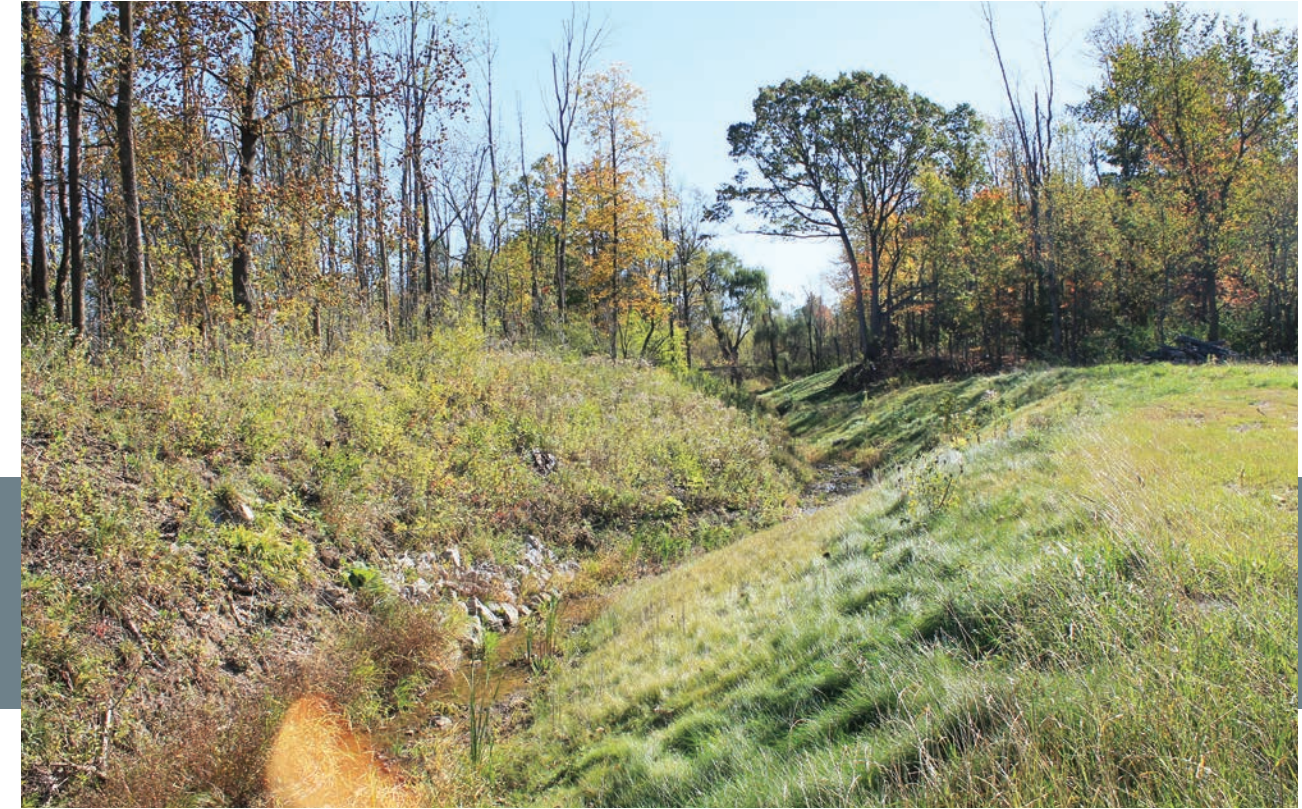
OPEN-CHANNEL
DRAIN DOWNSTREAM
OF WETLAND AREA.

A unique design component that was incorporated into the improvements was the use of an existing wetland area to both store and filter floodwater. The wetland area was located downstream from the intersection that was constantly plagued by flooding. The project team directed all storm water flows to this area and added a new 36-inch outlet at the upper end of the wetland area.

The 1.6-acre wetland uses natural processes to clean storm water before entering into an open-ditch area and eventually flowing away

from town. The wetland area serves as an excellent detention area, allowing discharge in heavy storm events to collect without causing flooding upstream or downstream. The project team also took extra steps to stabilize all bank areas where open-ditch construction was used, which will significantly prevent future erosion and reduce sediment loading.
