# STRAIGHT

# Winter 2017

- Spicer New Hires 2
- Oscoda Charter Township Wastewater Treatment Renovation 3
- 7 Demolition in Mt. Pleasant
- 9 Water Main River Crossing in Frankenmuth
- 13 Hess Road Water Main Repair
- 15 Fashion Square Boulevard Extension

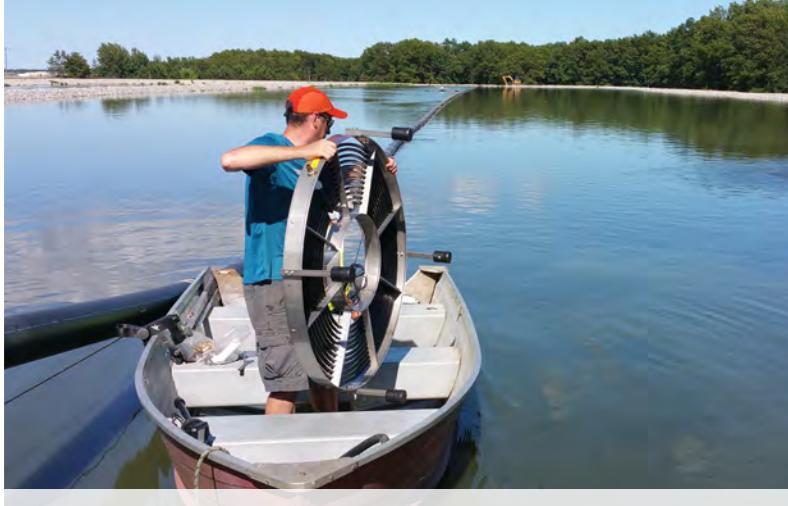
Contractor setting a diffuser in a lagoon cell

To comply with MDEQ standards, improve the wastewater treatment quality, and lengthen the system's useful age, the project included sludge removal, installing a new fine bubble aeration system, replacing the existing blowers, performing rapid infiltration basin distribution piping modifications, and adding a chemical feed mixing structure and effluent metering.

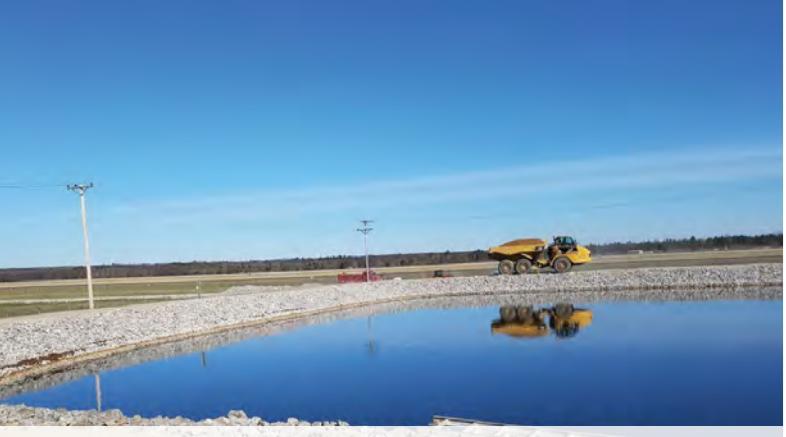
Riprap and blower pipe installation

The riprap will help the operators maintain the integrity of the lagoon's side slopes and control weed growth.

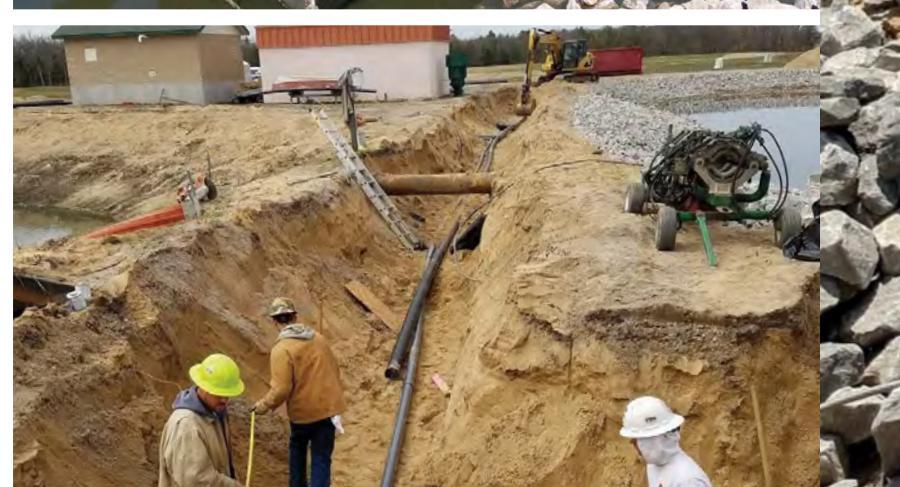
Blower pipe installation around lagoon cell

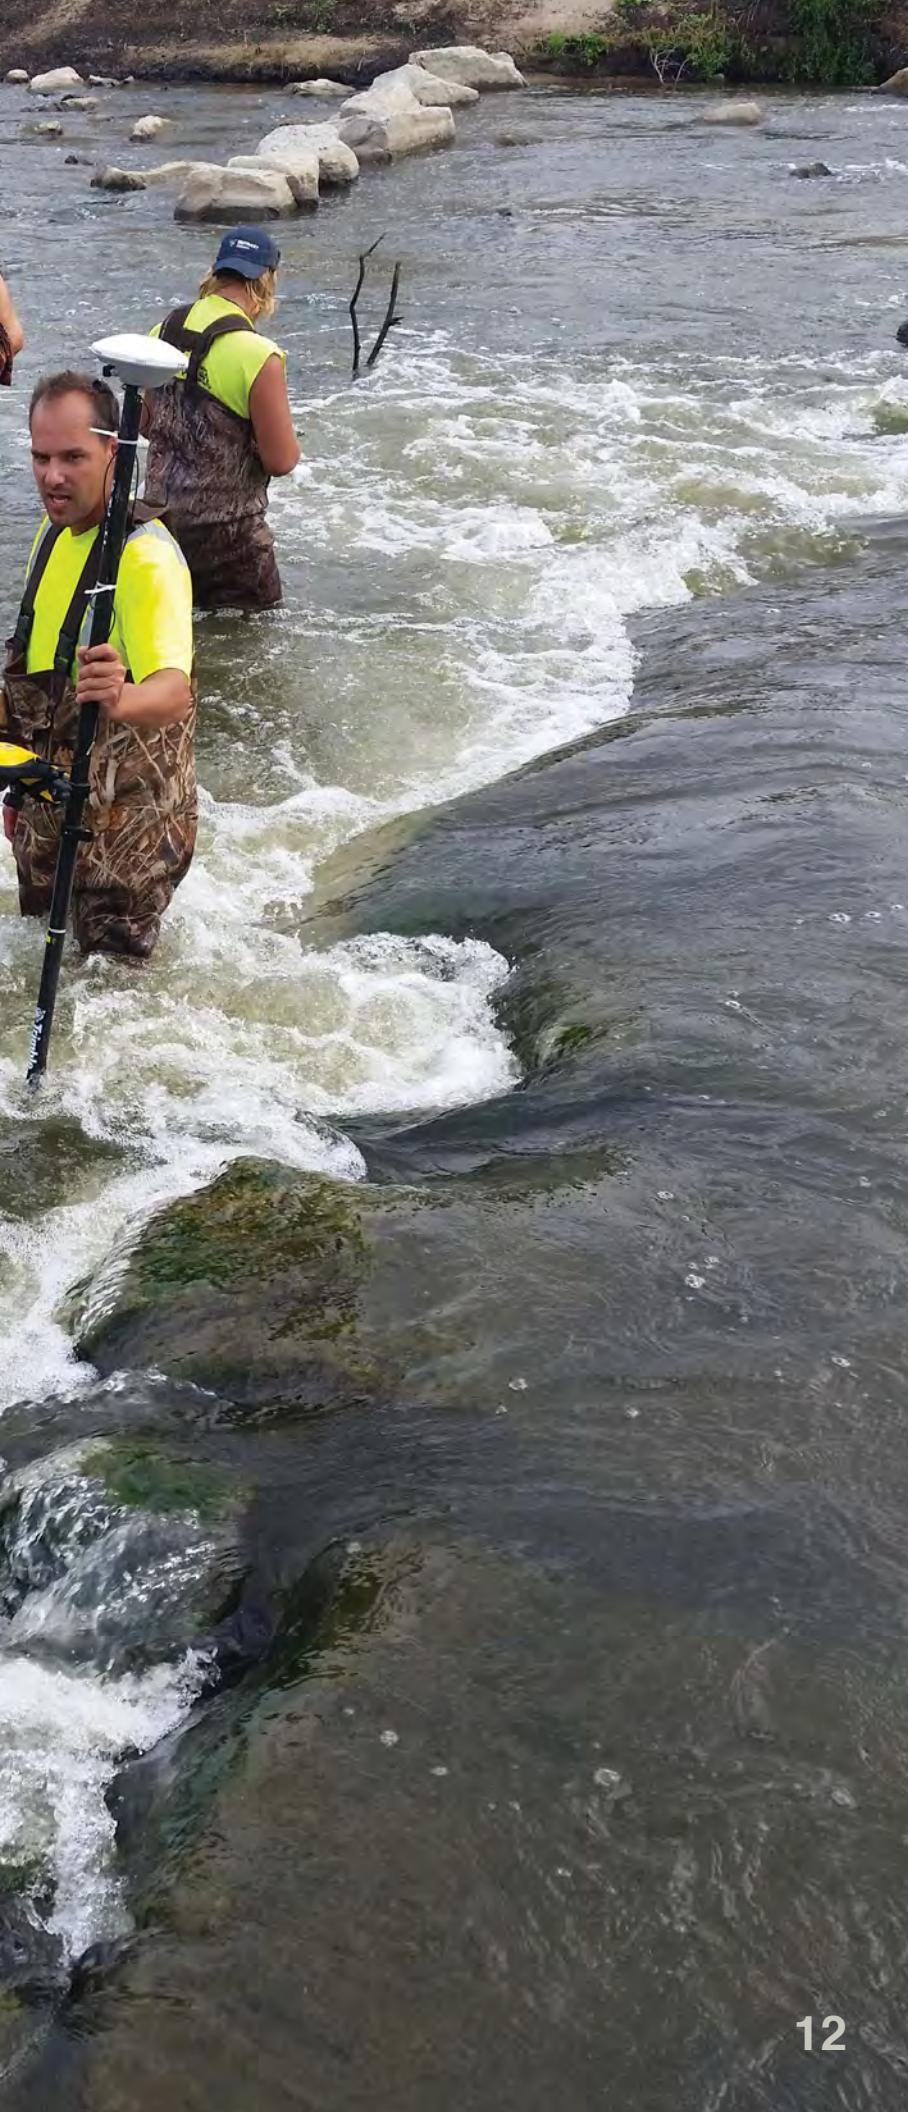
Contractors and Frankenmuth Water

Superintendent Ken O'Brien, center,

taking GPS coordinates of the drill head

beneath the Cass River in Frankenmuth

"There was a lot of shale and rock beneath the river," Rutkowski said. "The contractor had to use a thick rock head and specialized bore tip to get through it. Some of the rock was so hard they had to weld additional teeth onto the bore head. These were really complicated drilling conditions."

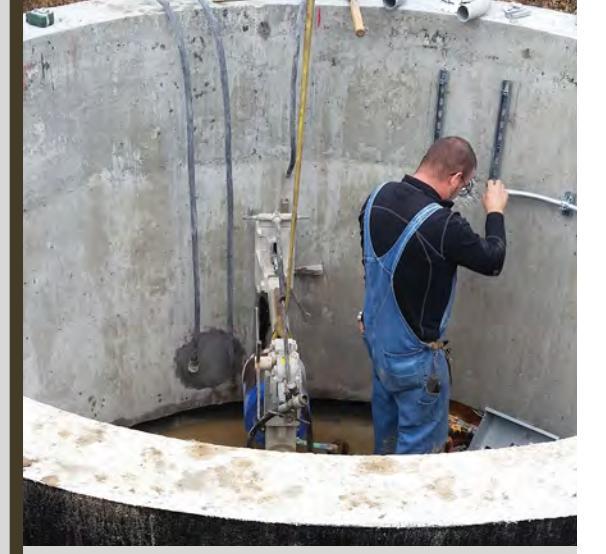
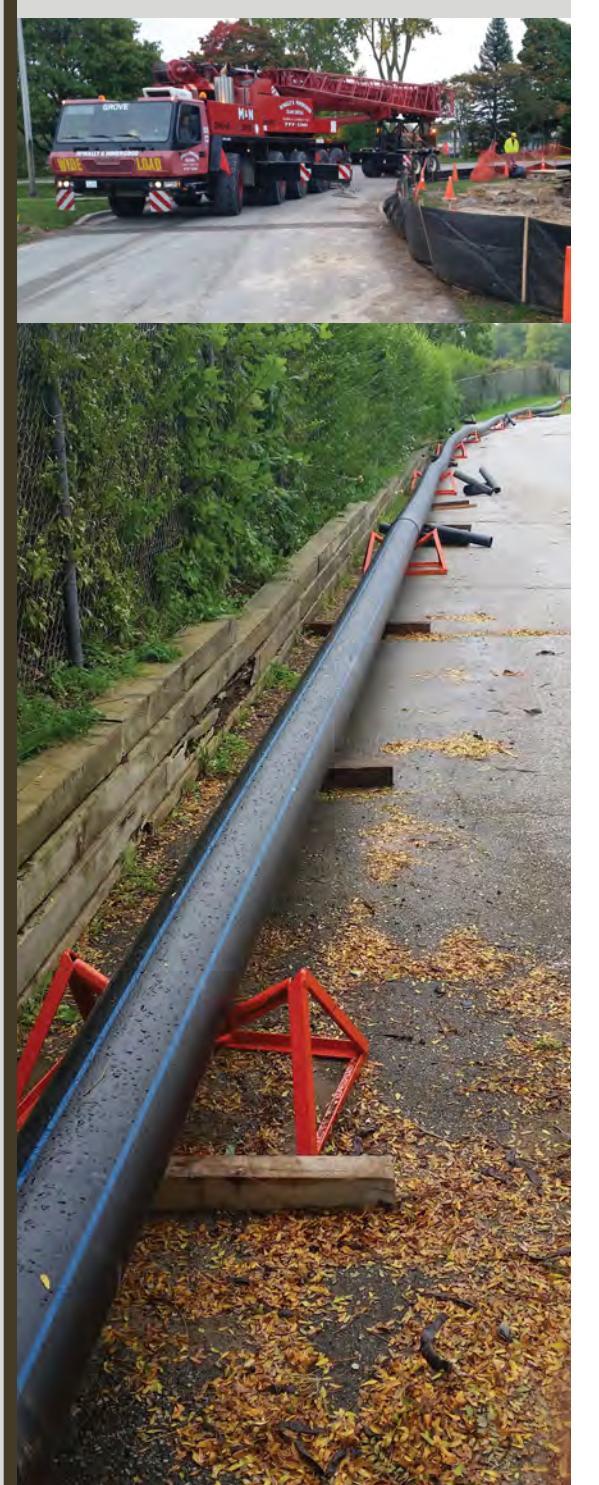
Above and below: PRV vault installation

A new pressure reducing valve vault was designed and installed on the west side of Plant Street with this project to help regulate the pressure zone throughout the water system on the north and south sides of the river.
